10" Wastewater Pipeline Rehabilitation

Elliptical Stormwater Pipe Rehabilitation

TxDOT Stormwater Box Culvert Rehabilitation

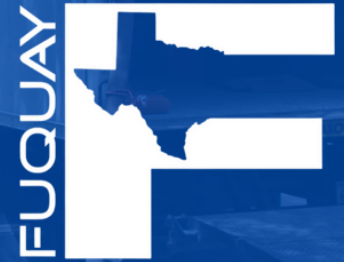
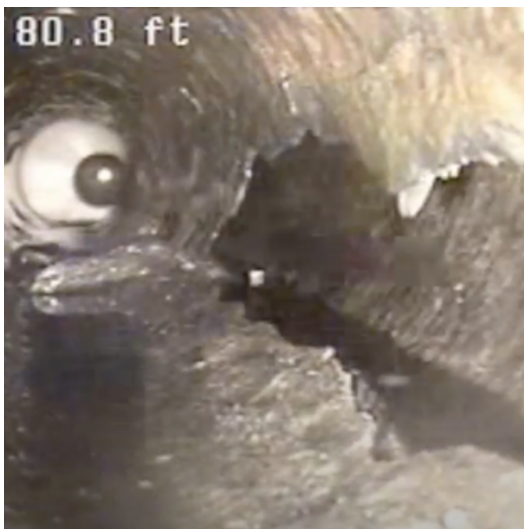
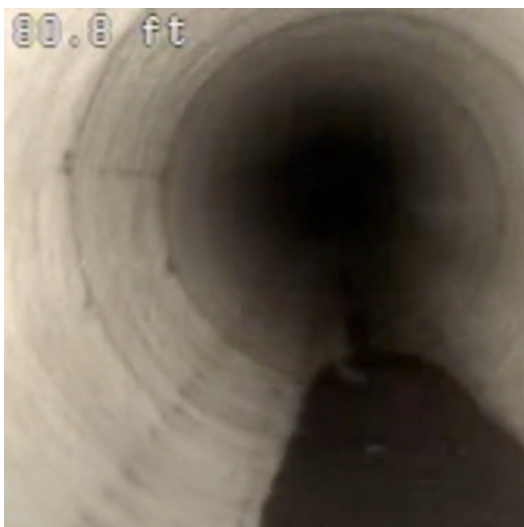
A Public Works department in southern Texas needed to replace 110 LF of cast iron pipe running underneath a heavily traveled highway. The 10" wastewater pipe was located inside a steel casing and had suffered extreme deterioration from prolonged exposure to hydrogen sulfide gas. Some sections of pipe were missing entirely, and voids riddled the aged horizontal asset. In this situation, the traditional dig-and-replace method was ruled out as a viable option due to the impact on the traveling public. Additionally, other trenchless methods could not be considered because the voids in the pipe would require point repairs to be done on the existing host pipe.

Fuquay was able to meticulously clean and televise the pipe in preparation for the lining process. During preparation, areas of severe corrosion were noted to avoid the threat of having equipment get damaged or lost down the large cavities of missing pipe directly under the highway. This is important because the retrieval process would have required a mass excavation effort—counterintuitive to the trenchless rehabilitation method. Fuquay crews successfully pulled the Alphaliner product into place and introduced air to the liner for expansion into the failing host pipe. With less than 8% elongation, the Alphaliner product was a perfect solution for this project. The liner was successfully cured in place without expanding into the pipe voids and mitigating the threat of a thinning liner that would lack structural integrity. Within 48 hours of Fuquay crews arriving on-site, the pipe was rehabilitated and returned to service without any trenches or a single lane closure.

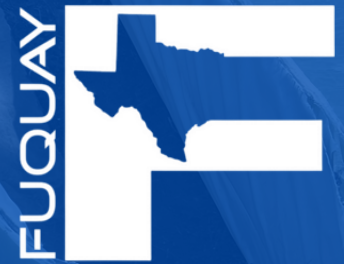
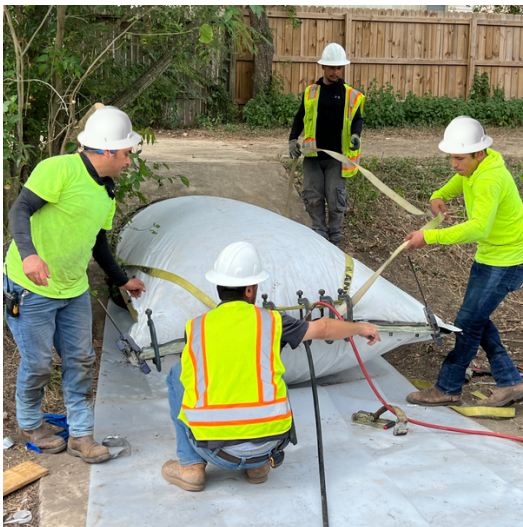
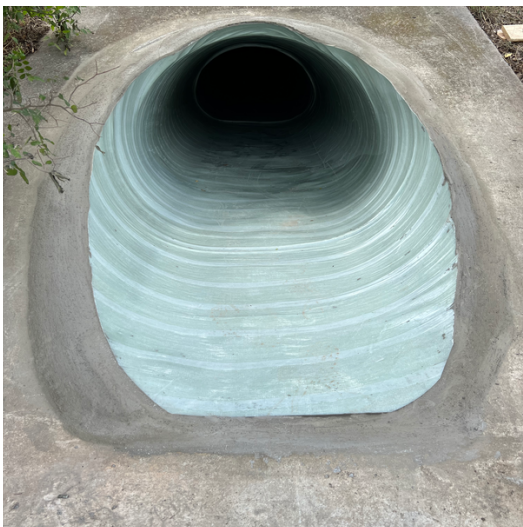
City officials in central Texas needed to replace 150 LF of corrugated metal stormwater pipe that had multiple failures and a collapsed section underneath the property of a homeowner on a busy, city street. The 58" x 36" elliptical-shaped pipe was located underneath multiple constituent properties in a densely populated neighborhood, creating a situation where access to the pipe was extremely limited. To dig and replace the pipe would be a messy, time-consuming, and costly task for city maintenance crews and a great inconvenience to the property owners. Further, the elliptical shape of the space reduced the amount of viable trenchless methods to repair the pipe. The rehabilitation process would require a custom-shaped liner engineered to withstand the load in the absence of an existing host pipe.

Fuquay crews were able to clean and remove debris from the stormwater pipe via man-entry and cut out the failed sections of the pipe. The crews were also able to clean and stabilize the collapsed section of pipe well enough to pull the Alphaliner into place without damage to the liner or equipment. Additionally, they were able to navigate the accessibility issues to get air introduced for inflation. After the curing process, minimal annular space remained between the existing pipe and the new fiberglass liner which dispelled any potential capacity issues. The concrete sections surrounding the pipe were repaired to ensure a smooth transition of flow into and out of the stormwater pipe. Within 48 hours of arrival on-site, Fuquay crews had rehabilitated the pipe and demobilized without disturbing a single property owner.

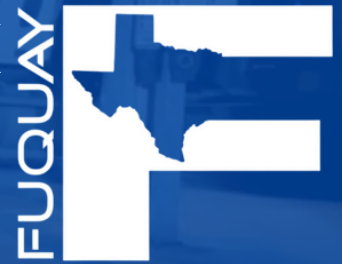
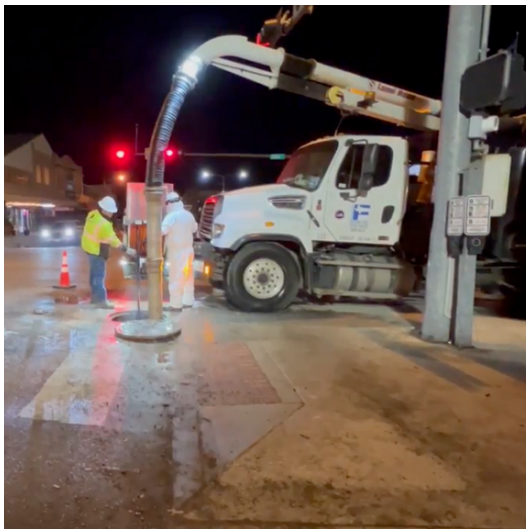
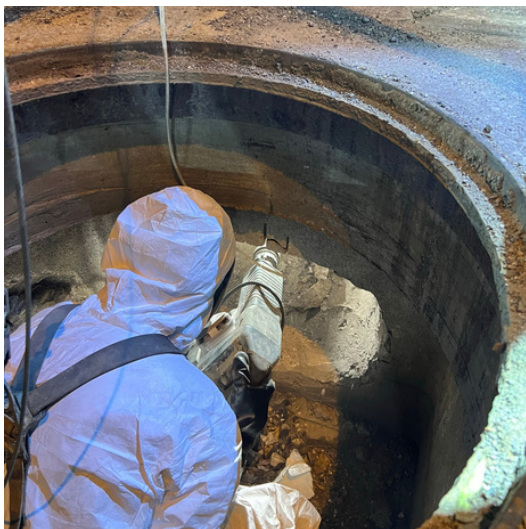
In late December of 2022, TxDOT needed to replace the existing stormwater box culvert that was full of debris, failing, and near collapse. The structure was located underneath Hamilton's central downtown intersection of TX-36 and U.S. 281, with heavy, in-town traffic.

Fuquay cleaned and relined the box culvert in less than 36 hours and kept traffic lanes open to the traveling public for the entirety of the project.

The box culvert was lined with a resin-impregnated fiberglass liner, which was then cured with UV light. Grout was then injected into the remaining annular space between the new pipe and the existing substrate.
